TRENCHLESS MIDDLE EAST CONFERENCE

THE EN ISO11295 FAMILY OF STANDARDS AND PE100+ NO-DIG GUIDE CONCERNING PIPELINE REHABILITATION USING POLYETHYLENE PIPES AND LINERS

Andrew Wedgner¹ and Cindy Wang² on behalf of Borouge Pte.

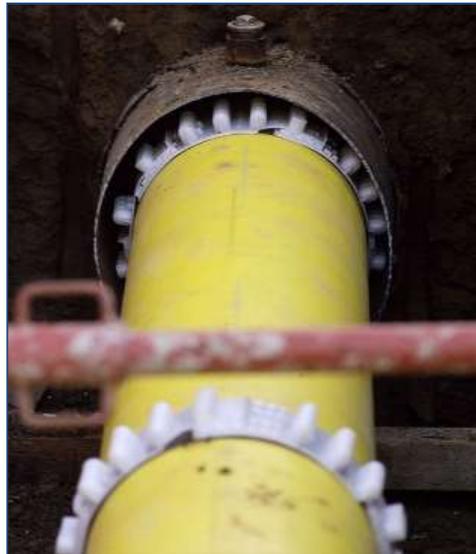
Figure 5. Plastic spacers centralise the PE80 liner in the gas main

It was proposed that a 160m section of the main would be renovated using 400mm SDR11 PE pipe using slip lining. The local gas company AEM specified that the liner pipe should be produced from BorSafe™ ME3441 MDPE PE80 material in order to ensure that the pipe met their performance requirements yet was flexible enough to minimise disruption in the centre of the city. This material is a bimodal MDPE with an exceptionally high stress crack resistance and a high resistance to rapid crack propagation, which would enable the mains pressure to be raised once all the renovation was completed. The 400mm SDR11 pipe was produced in 6m lengths by Idrotherm 2000 S.R.L. On site the pipe lengths were butt welded and attached to a pulling head to enable them to be drawn through the 160m of steel main. Plastic spacers were used to centralize the PE pipe in the host main.

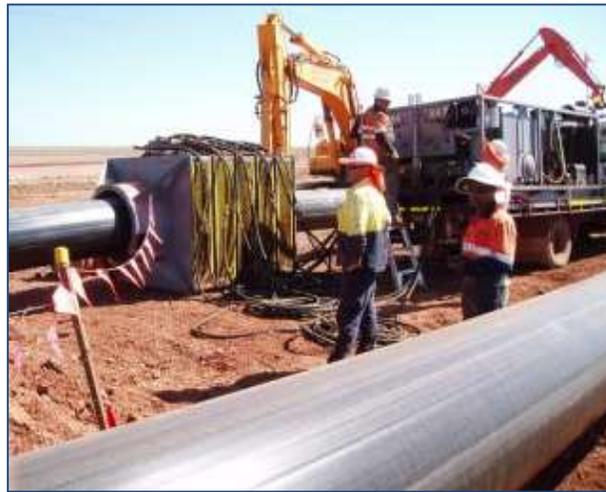
Figure 6. Reducing the diameter of the PE100-RC liner pipe prior to insertion.

The pipes were extruded by Kingston Bridge and delivered to site where they were butt welded together and then inserted into the steel pipes by United Pipelines using their “Tite Liner” technology. Before insertion the PE pipes are drawn through a hydraulically powered roller reduction box which reduces the outside diameter of the pipe as shown in figure 6. This smaller diameter PE pipe was then easily pulled through the steel pipe and once in position the load was released so allowing the pipe to try and revert to its original diameter, so forming a tight compression fit with the bore of the host pipe where it protected the pipe from abrasion and corrosion.

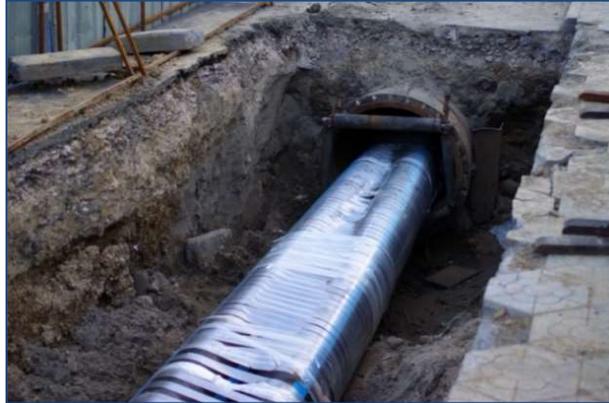
Figure 7. The pipe folded and strapped being inserted into the old water main

For the project a non-standard 983mm diameter pipe with a 15mm wall thickness was manufactured by Shanghai Chinaust using a PE100-RC material. On site the team from the Shanghai Water Special Engineering Co. butt welded the pipe sticks together and removed the external bead prior to passing the pipe through a folding machine that formed it into a “U” shaped section. Strapped in this form the effective diameter of the liner pipe was greatly reduced and it could be easily inserted into the bore of the old pipe.

Once in position the PE100-RC pipe was pressurised to break the strapping and to form a close fit liner, which eliminated leakage and prevented further drinking water contamination, thereby providing the water company with a very cost effective solution.

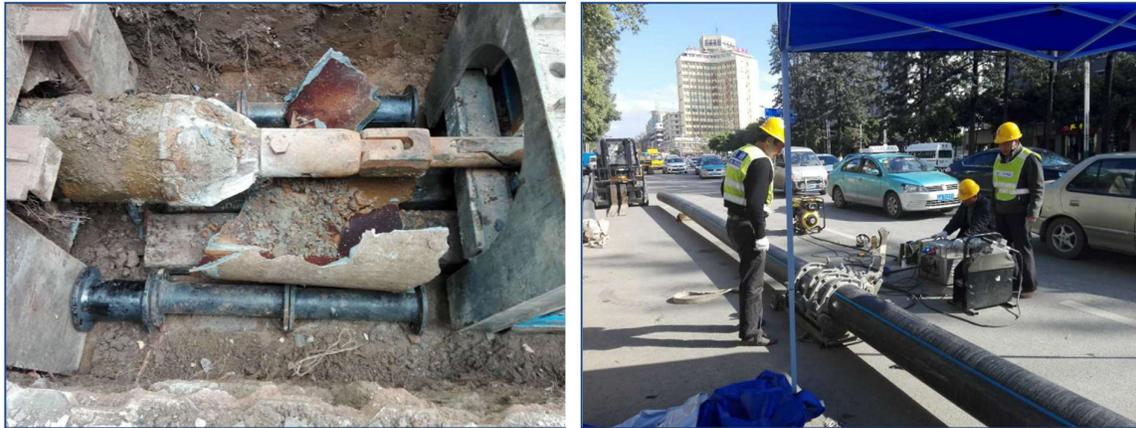
Old pipe after pipe bursting

New butt welded PE pipes

Figure 8. Replacing old asbestos water main in the Southwest of China through pipe bursting

A second example, which took place in Oct. 2015 involved the replacement of existing water mains using pipe bursting technology. The existing water mains comprised a DN 200 mm cast iron pipeline and a DN 280 mm asbestos cement pipeline that were replaced by a 225 mm OD, SDR11 and a 315 mm OD SDR11 PE100 pipelines respectively. Whilst pipe bursting is an effective trenchless way of replacing existing pipelines with the same or slightly larger diameter PE pipelines, the installation process can lead to the new pipeline being badly scratched or scored. Hence SADE again decided to use polyethylene pipes produced using a PE100-RC pipe resin in order to minimise the risk of failure due to SCG in the long term.

After being delivered to site in 6m ‘sticks’ the pipes were butt welded together by SADE using a semi-automatic welding machine to help ensure good quality welding of the pipes strings that were then pressure tested prior to installation. The new pipeline lengths installed by pipe bursting were 950 m in the case of the 225 mm OD pipeline and 800 m in the case of the 315 mm OD pipeline.
